Pre-Purchase Survey of 'Raven Moon'

Report Number: 101125-001

Survey Date: 10th November 2025

Type: Widebeam Narrowboat

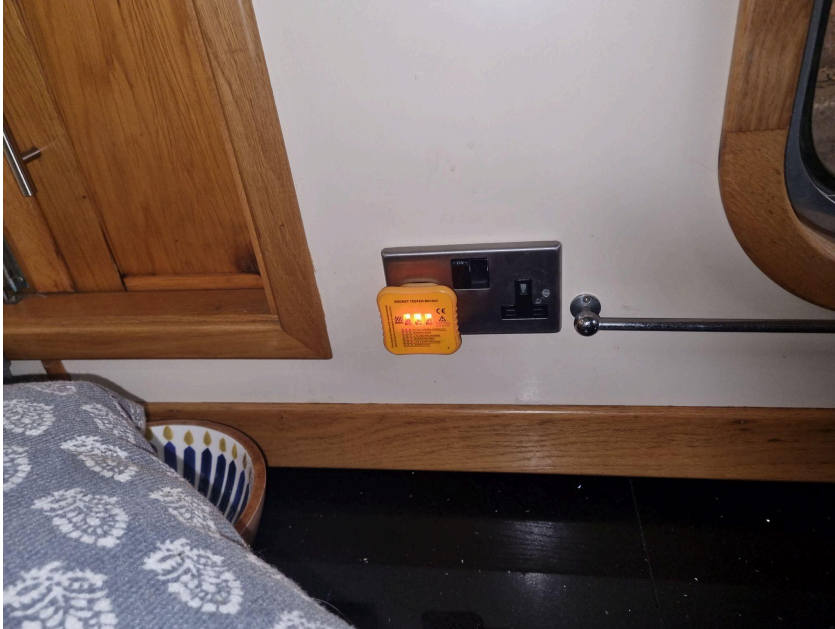
23.1 20V: The 240V installation was seen to be of a professional standard. This was seen working and checked with a socket tester with no defects registered. The vessel has shore power capabilities, but this was not checked with a shore power lead.

Socket outlet test

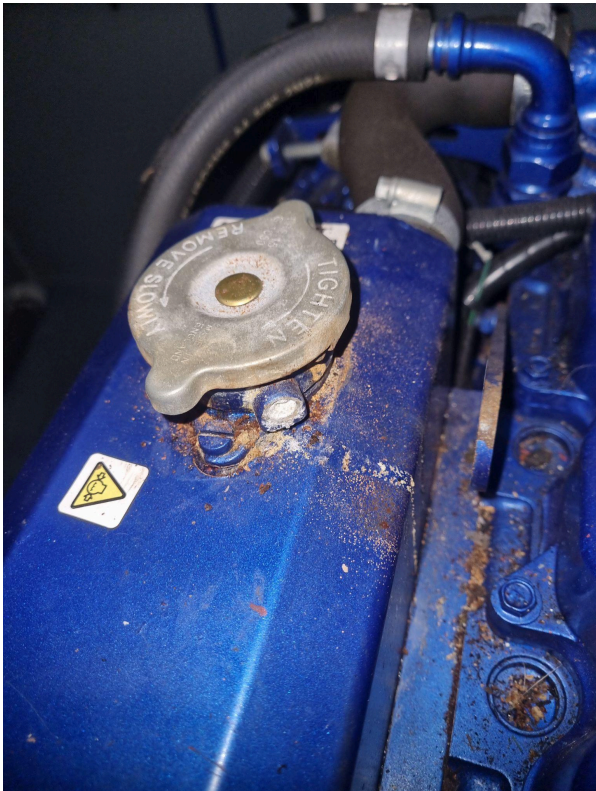
18.4 The engine was cooled via 1 skin tank that was found to be in serviceable condition; however, there was no way of checking the coolant as the header tank cap was rusted and may have broken if forced. This will need replacing and the coolant checked.

Coolant cap

(A) Replace the coolant cap and check the coolant levels.

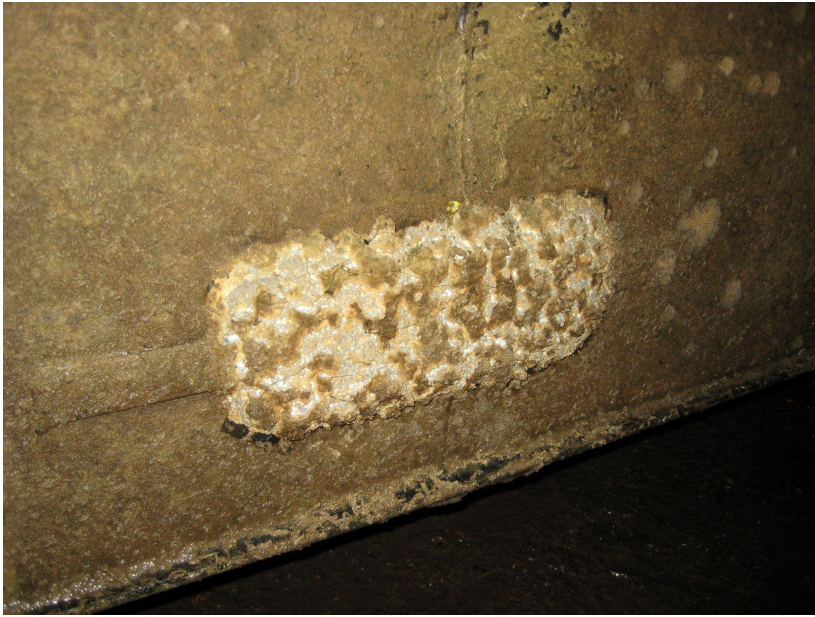
Six 300mm (2.5kg) anodes, welded to the hull, are spent and require replacement. A shaft anode was installed at the propeller nut and was in serviceable condition.

Spent anodes that require replacement.

(B) Replace all anodes

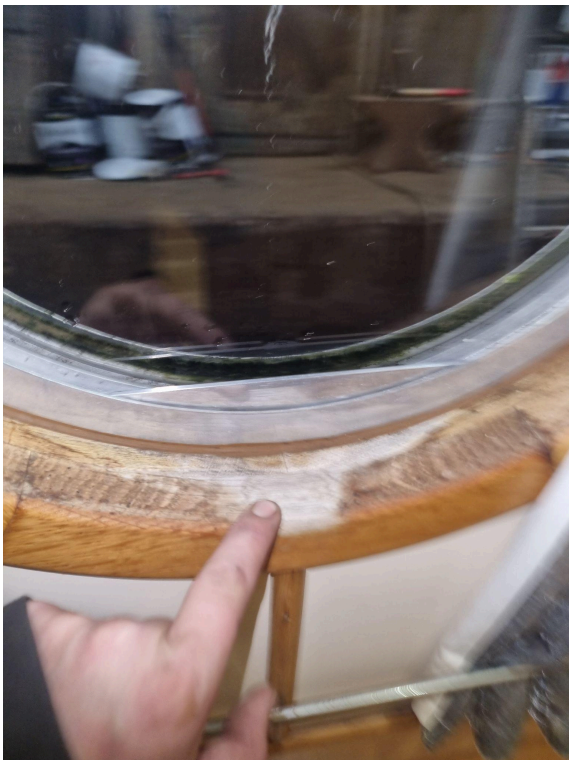
12.3 The window frames and surrounding panelling in the lounge area were seen to have minor historical water damage; the integrity was not affected, and this may have been caused by the window ducts being clogged.

Watermarks beneath windows

(B) Maintain widows, seals and drainage ducts to prevent water damage.
