**Survey number 240226-01**

**Insurance renewal survey**

Survey Date: 24th Feb 2026

Designer/ builder: Fairline  
Model: Targa 33  
Type: Motor Cruiser  
Year of build: 1996  
Length overall: 10.4m  
Beam: 3.4m  
Max Draft: 1.2m  
Displacement: 5000kg ( unverified)  
Hull/Serial number:  
Construction material: GRP  
Engine: 2 x Volvo Penta AD41 P-A  
Fuel type: Diesel  
Engine serial numbers: Not known  
Engine Power: 200hp each  
Boat safety scheme number. N/A  
Environmental Agency number: N/A  
Carving marks RT: ON:  
Any other identifying numbers: British Waterways No:  
Berths: 2  
Call sign: unknown  
Yard: Port Solent Marina Hard Standing  
Vessel particulars were obtained from the owner and, where possible, verified by visual inspection.  
Intended use: Coastal Cruising.

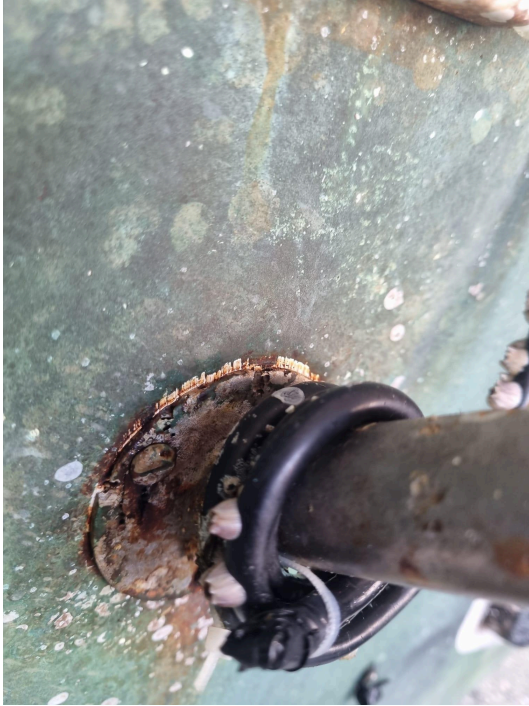
3.4 The bathing platform was bolted on through the transom and supported by 3 stainless steel struts. There was gelcoat damage in several areas, exposing the laminate to water. The centre strut was seen to have moved, and on closer inspection, it was found to be shaken vigorously and observed to be moving at the fixings. Some pitting was also seen. A cable was found coiled around the centre strut, believed to be live, and stray corrosion is evident on the struts. The bathing platform did not move when shaken. The fixings should be removed and replaced, as worn screws could cause the strut to move, wear away the gelcoat, and expose the transom wood.

***Bathing platform strut fixings with pitting and a cable wrapped around it.***

- (A) Remove the bathing platform strut and fixings for further inspection, replace or repair where required.**
- (B) Periodic removal of the bathing upholstery on the foredeck to inspect and clean the area and fixings.**
- (C) Repair gelcoat damage on the bathing platform to prevent moisture ingress into the laminate.**

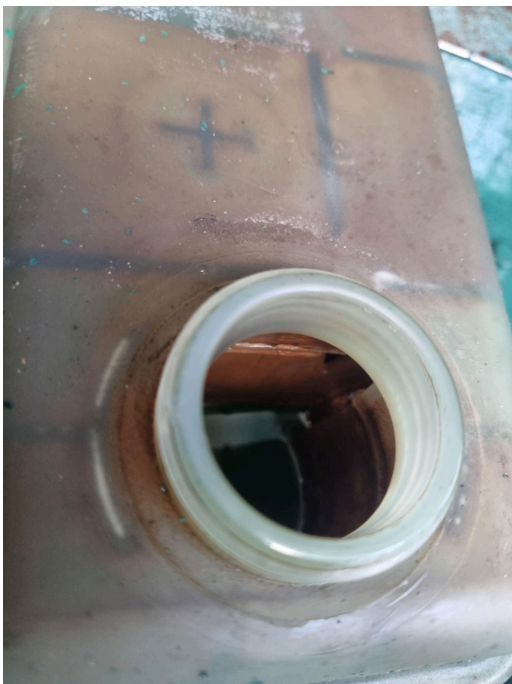
The coolant header tanks were inspected on both engines, and the coolant level on the Port engine was very low. Further investigation is needed to ascertain the cause of the leaks, which will be done while the engine is running. The starboard engine coolant was at an acceptable level and in serviceable condition. The coolant used was green, in line with the manufacturer's specifications.

***Port engine coolant***

**(B) Further investigation is required into the low coolant level found on the port engine.**

**(B) Check all hose clips for any that may need tightening, as this could be a cause of coolant loss.**

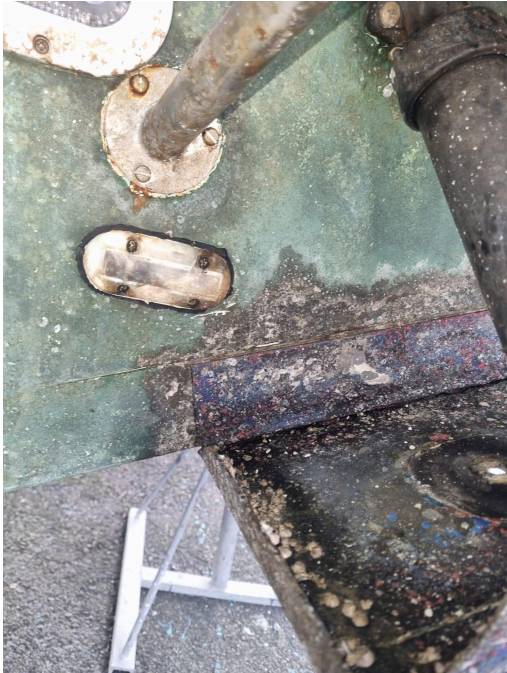
***Underwater light with water in the lens***

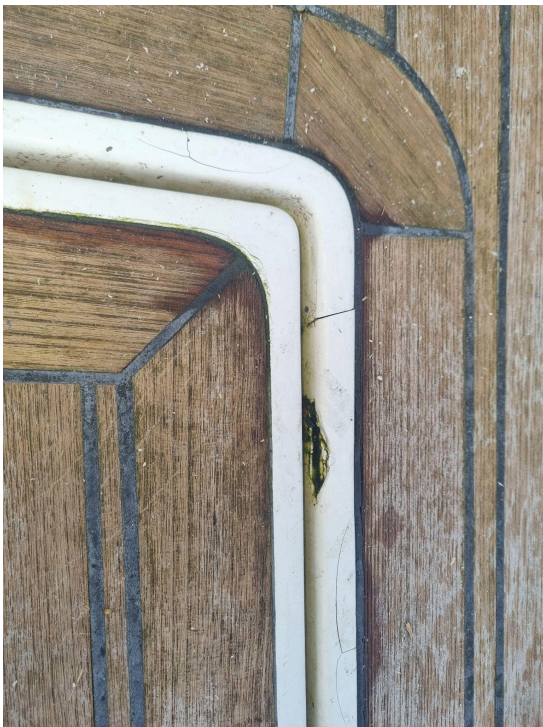
***Bathing platform gelcoat damage***

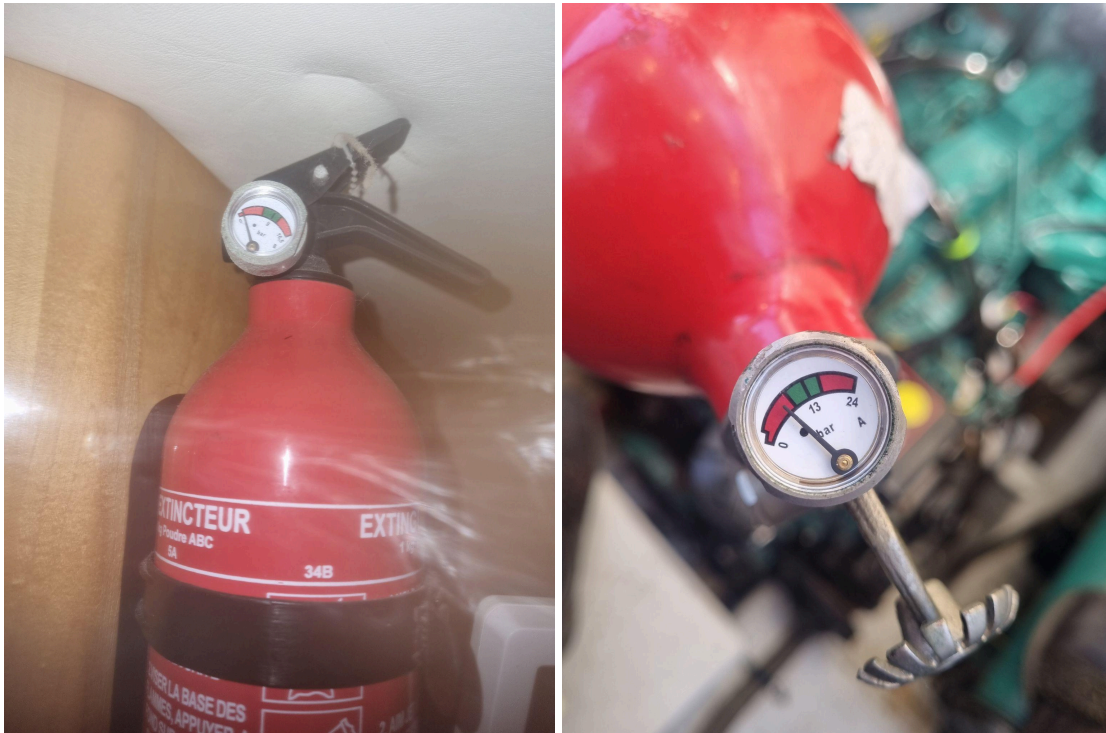
***Fire extinguishers***

It is recommended that fire extinguishers be replaced every 10 years, and dry powder extinguishers should be regularly turned over to prevent the contents from compacting. Fire extinguishers should be tested and recharged every 5 years.

(B) Replace all fire extinguishers.

(C) Regular checks of firefighting equipment should be carried out to ensure it is in good working condition

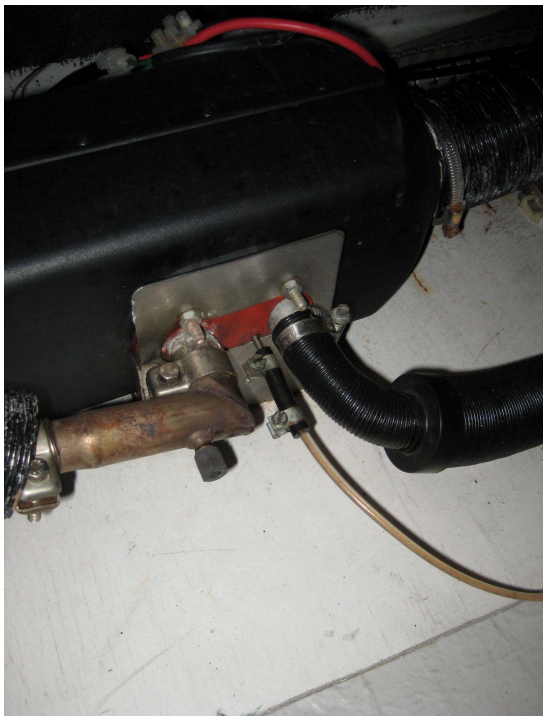
17.4 The diesel heater was fed a black hose that was of ISO7840 standard, which was securely fixed where seen, and the diesel fuel tank could not be fully inspected due to the location of the installation. Still, no diesel was seen in the bilge, and there was no smell of diesel throughout the boat. Further investigation showed that part of the diesel heating fuel system lacked an ISO-rated fuel line, and it is recommended that an ISO 7840 fuel hose be used on the diesel heater.

***Diesel heater fuel hose.***

**(A) It is recommended that an ISO 7840 fuel hose be used to feed the diesel heater, and the current fuel hose should be changed.**
